**Flood Control Project Maintenance
Levee Inspections**

Fall 2013 Levee Maintenance Deficiency Summary Report

Reclamation District No. 0563 Tyler Island

Waterway			Bank	Unit Miles
Unit No. 01 Georgiana Slough (Tyler Island)			Left	12.38
	Spring (March - May)	Summer (June - August)	(September - November) Fall	Winter (December - February)
Unit Maintenance Rating (Fall Only)			U	
Date of Inspection	04/24/2013 - 04/24/2013		10/15/2013 - 10/16/2013	
DWR Inspector	Richard Willoughby		Richard Willoughby	
Accompanied By	Steve Mello RD 563		Steve Mello RD 563

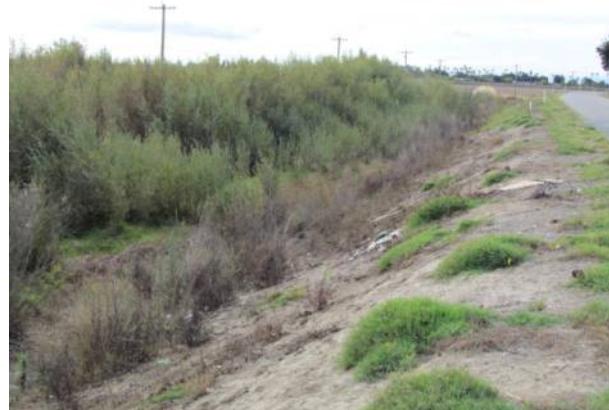
Levee Mile Report Line	89
Start Levee Mile	7.97
End Levee Mile	8.10
Location	Land Side
Category	Earthen Levee
Item	Vegetation
Looking south at dense vegetation on landside toe. (2012 Fall Inspection)	
richard_f_20130930_722.JPG

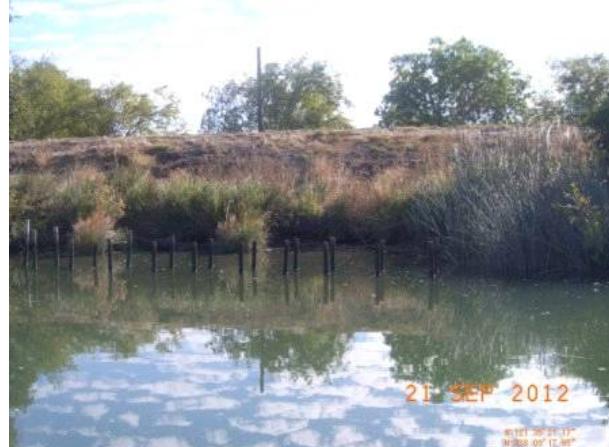
USACE 2012 Photo #1

90	8.28	8.76	Supplemental USACE Erosion Survey	WS U Ma		Inspector Comments: 1997 - Pockets of erosion into the levee at the water line. Alders are being undercut and rotating out into the channel. Damaged rock at upstream end. 2000 - New minor erosion. 2001 - Staked low fascine walls at bankline. 2002 - New "Brush Boxes" along the bank toe. 2003 - New erosion pockets in the middle of the site. 2005 - Some new bundles in the brush boxes. 2011 - Site upgraded to CRITICAL. Significant new erosion. Sites 3.6, 3.7, 3.71, and 4.0 were combined. 2012: Rock has been placed in some of the erosion pockets since last year, however site remains critical. [2012 Site ID: GEO_3-8_L]	38.156987 ° -121.587427 °	38.152919 ° -121.591129 °	48 Y	DWR ID:

Levee Mile Report Line	90
Start Levee Mile	8.28
End Levee Mile	8.76
Location	Water Side
Category	Supplemental
Item	USACE Erosion Survey

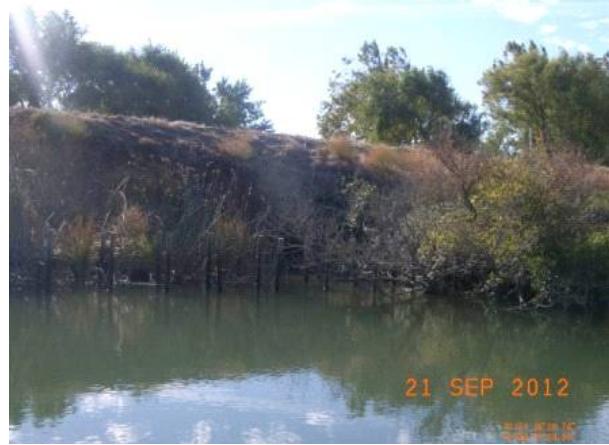
USACE 2012 Photo #2

Levee Mile Report Line	90
Start Levee Mile	8.28
End Levee Mile	8.76
Location	Water Side
Category	Supplemental
Item	USACE Erosion Survey

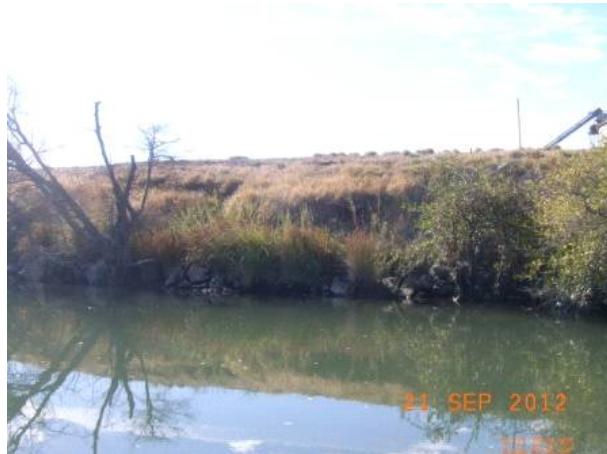
USACE 2012 Photo #4

Levee Mile Report Line	90
Start Levee Mile	8.28
End Levee Mile	8.76
Location	Water Side
Category	Supplemental
Item	USACE Erosion Survey

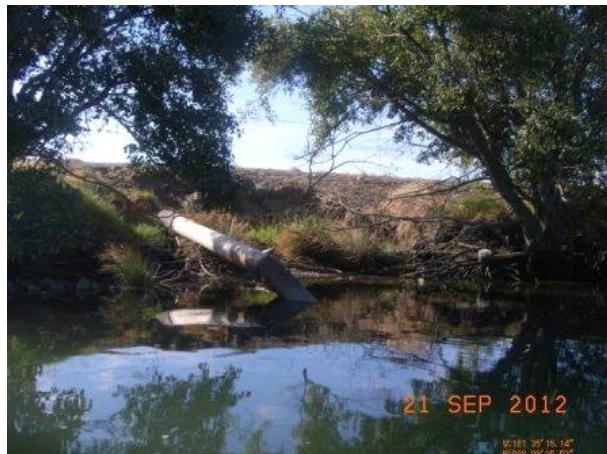
USACE 2012 Photo #5

Levee Mile Report Line	90
Start Levee Mile	8.28
End Levee Mile	8.76
Location	Water Side
Category	Supplemental
Item	USACE Erosion Survey

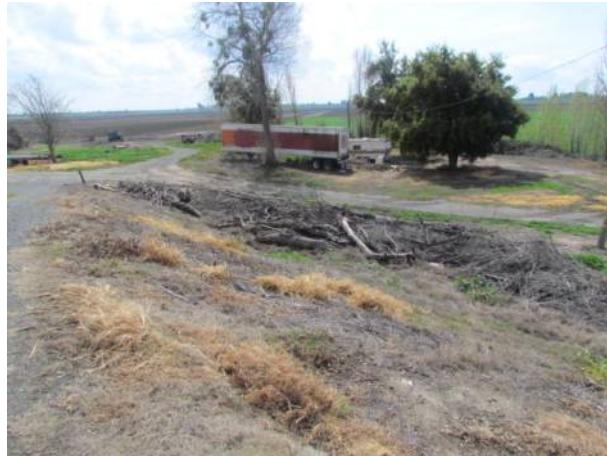
Levee Mile Report Line	95
Start Levee Mile	9.50
End Levee Mile	9.50
Location	Land Side
Category	Earthen Levee
Item	Encroachments
Looking east at prunings on landside slope and toe.	
richard_f_20130930_697.jpg

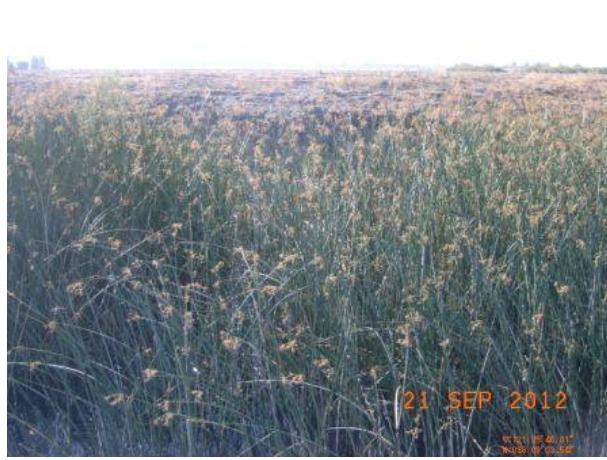
Levee Mile Report Line	96
Start Levee Mile	9.74
End Levee Mile	9.92
Location	Water Side
Category	Supplemental
Item	USACE Erosion Survey
USACE 2012 Photo #1	
USACE2013_GEO_2-5_L_1.jpg

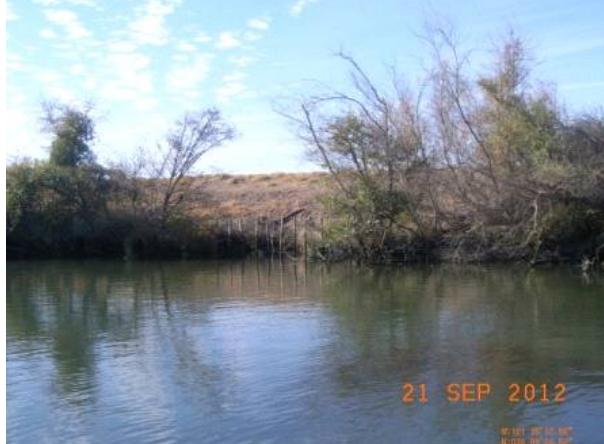
USACE 2012 Photo #2

Levee Mile Report Line	96
Start Levee Mile	9.74
End Levee Mile	9.92
Location	Water Side
Category	Supplemental
Item	USACE Erosion Survey

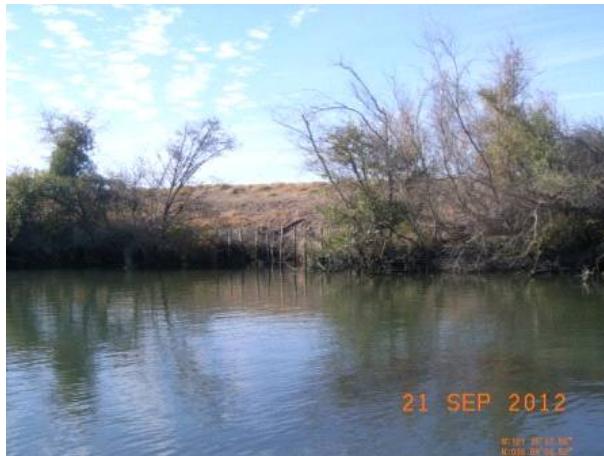
USACE 2012 Photo #1
USACE2013_GEO_2-0_L_1.jpg

Levee Mile Report Line	100
Start Levee Mile	10.17
End Levee Mile	10.29
Location	Water Side
Category	Supplemental
Item	USACE Erosion Survey

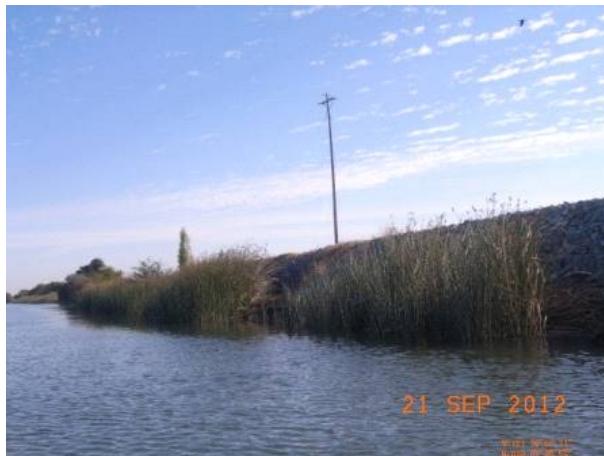
USACE 2012 Photo #2
USACE2013_GEO_2-0_L_2.jpg

Levee Mile Report Line	100
Start Levee Mile	10.17
End Levee Mile	10.29
Location	Water Side
Category	Supplemental
Item	USACE Erosion Survey

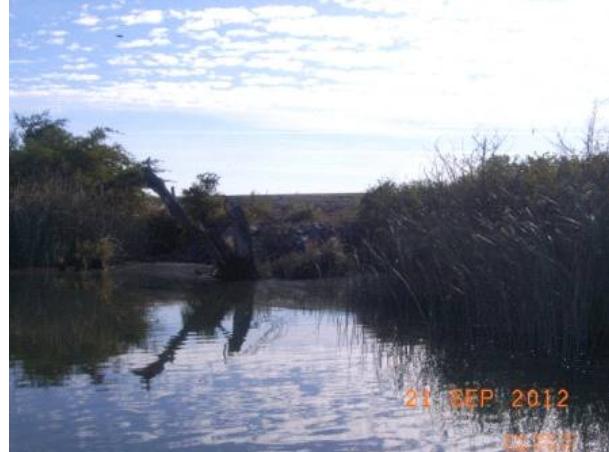
USACE 2012 Photo #4

Levee Mile Report Line	100
Start Levee Mile	10.17
End Levee Mile	10.29
Location	Water Side
Category	Supplemental
Item	USACE Erosion Survey

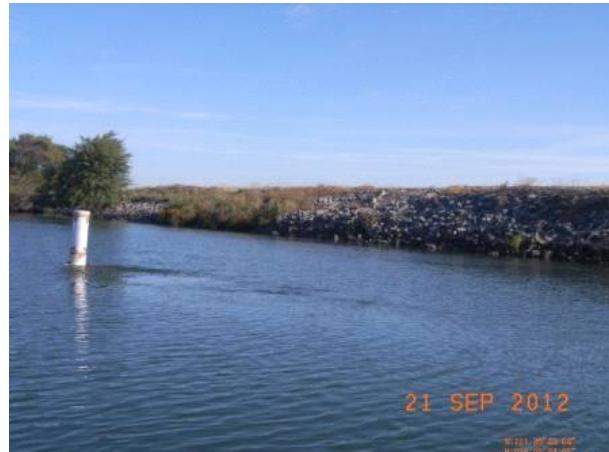
USACE 2012 Photo #1

-121.599433 °	-121.600581 °	Y	
								DWR ID:			
101	10.46	10.76	Supplemental USACE Erosion Survey	WS Ma	M		Inspector Comments: 1997 - Old damaged rock riprap along the toe. 1999 - Downstream end (400 ft) repaired with rock. 2002 - New rock/concrete rubble section on the downstream end. 2004 - Small pocket repairs at the downstream end. 2005 - Some new bundles in the brush boxes. 2012: Some rock has been placed in last year. [2012 Site ID: GEO_1-7_L]	38.143519 °	38.139918 °	53	
								-121.599677 °	-121.596986 °	Y	
								DWR ID:

Levee Mile Report Line	101
Start Levee Mile	10.46
End Levee Mile	10.76
Location	Water Side
Category	Supplemental
Item	USACE Erosion Survey

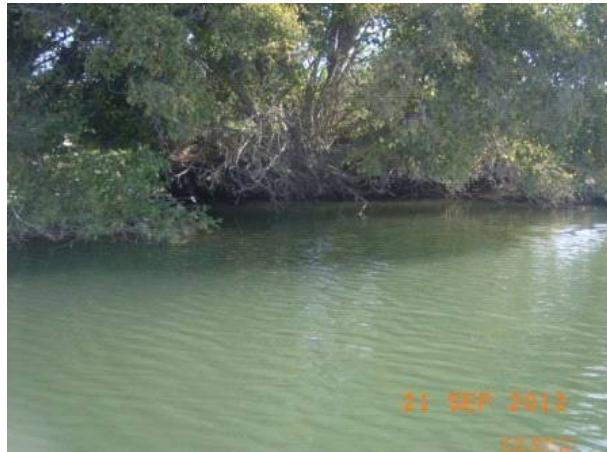
USACE 2012 Photo #3

Levee Mile Report Line	101
Start Levee Mile	10.46
End Levee Mile	10.76
Location	Water Side
Category	Supplemental
Item	USACE Erosion Survey

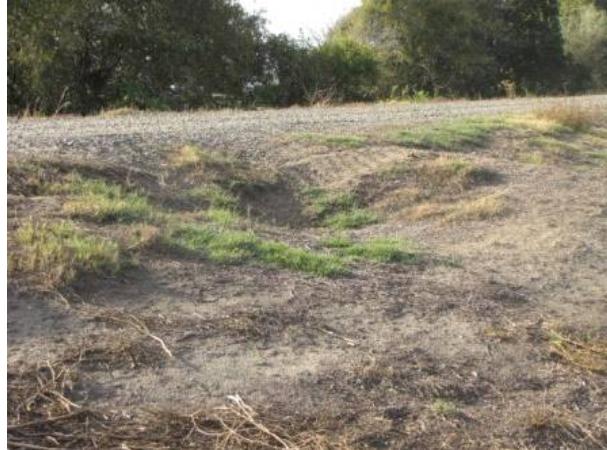
Levee Mile Report Line	102
Start Levee Mile	10.77
End Levee Mile	10.77
Location	Land Side
Category	Earthen Levee
Item	Slope Stability
Looking west at depression on landside shoulder and slope.	
richard_f_20130930_702.jpg

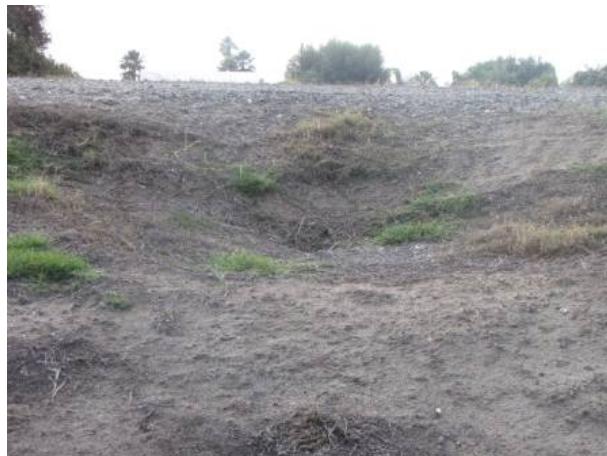
Levee Mile Report Line	102
Start Levee Mile	10.77
End Levee Mile	10.77
Location	Land Side
Category	Earthen Levee
Item	Slope Stability
Looking west at depression on landside shoulder and slope from landside toe.	
richard_f_20130930_703.jpg

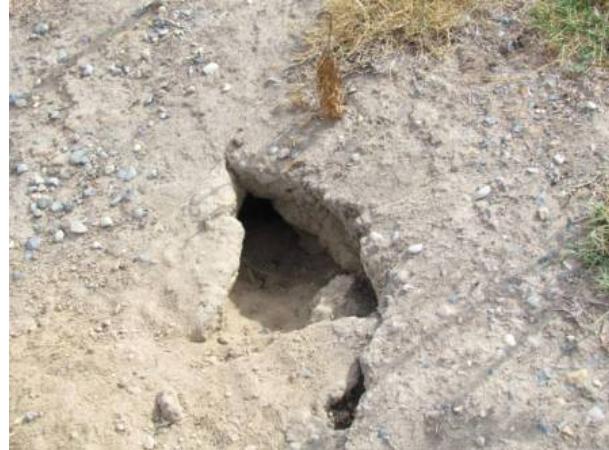
richard_f_20130930_723.jpg

Looking east at rodent hole on landside slope.

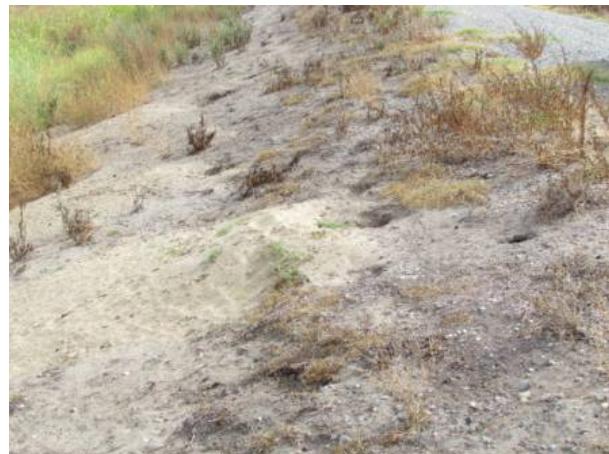
richard_f_20130930_724.jpg

Levee Mile Report Line	106
Start Levee Mile	11.63
End Levee Mile	11.63
Location	Land Side
Category	Earthen Levee
Item	Animal Control

Looking south at rodent holes on landside slope.

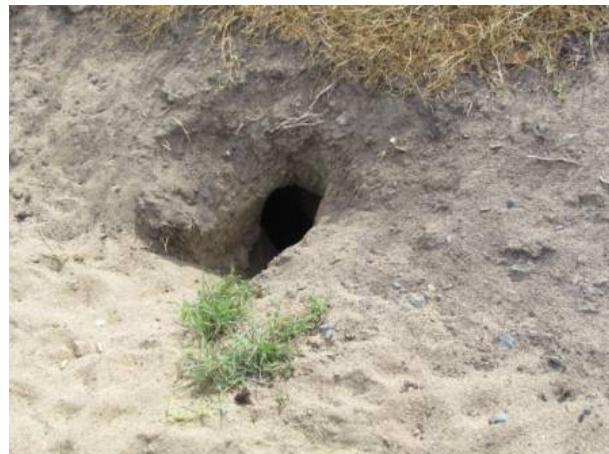
richard_f_20130930_725.jpg

Levee Mile Report Line	106
Start Levee Mile	11.63
End Levee Mile	11.63
Location	Land Side
Category	Earthen Levee
Item	Animal Control

Looking west at rodent hole on landside slope.

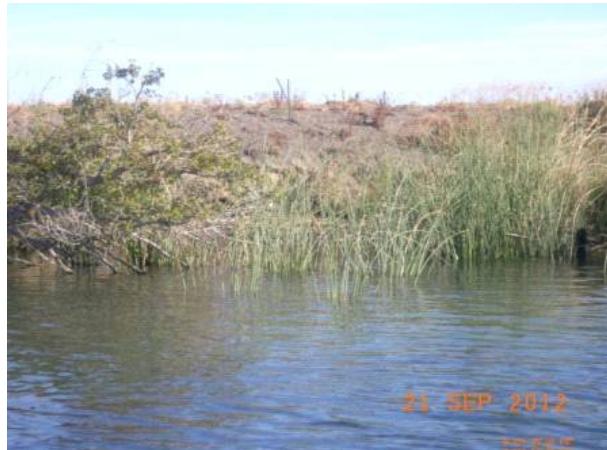
USACE 2012 Photo #2

Levee Mile Report Line	107
Start Levee Mile	11.69
End Levee Mile	12.04
Location	Water Side
Category	Supplemental
Item	USACE Erosion Survey

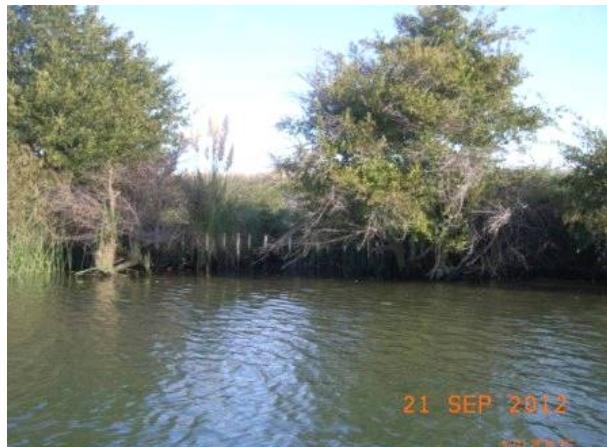
USACE 2012 Photo #3

Levee Mile Report Line	107
Start Levee Mile	11.69
End Levee Mile	12.04
Location	Water Side
Category	Supplemental
Item	USACE Erosion Survey

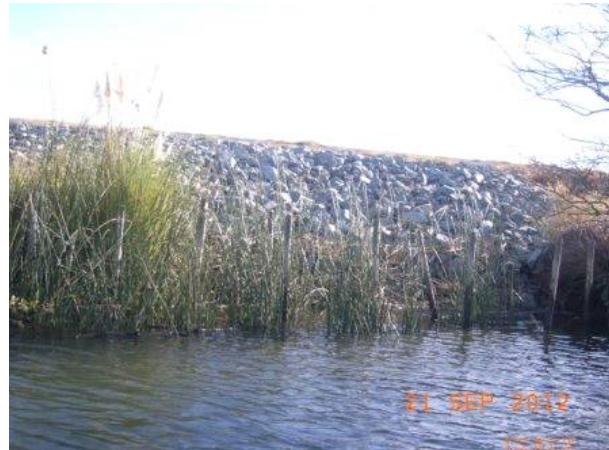
USACE 2012 Photo #5

Levee Mile Report Line	107
Start Levee Mile	11.69
End Levee Mile	12.04
Location	Water Side
Category	Supplemental
Item	USACE Erosion Survey

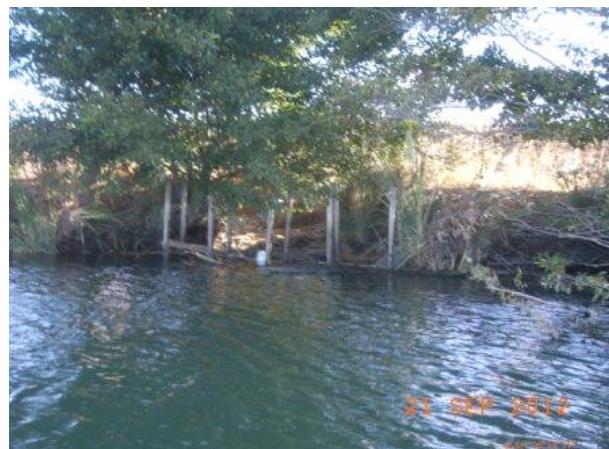
USACE 2012 Photo #6

Levee Mile Report Line	107
Start Levee Mile	11.69
End Levee Mile	12.04
Location	Water Side
Category	Supplemental
Item	USACE Erosion Survey
